NASA TECHNICAL NOTE

EVALUATION OF A CONTACT-ANALOG DISPLAY IN LANDING APPROACHES WITH A HELICOPTER

by Robert W. Sommer and R. Earl Dunham, Jr.

Langley Research Center

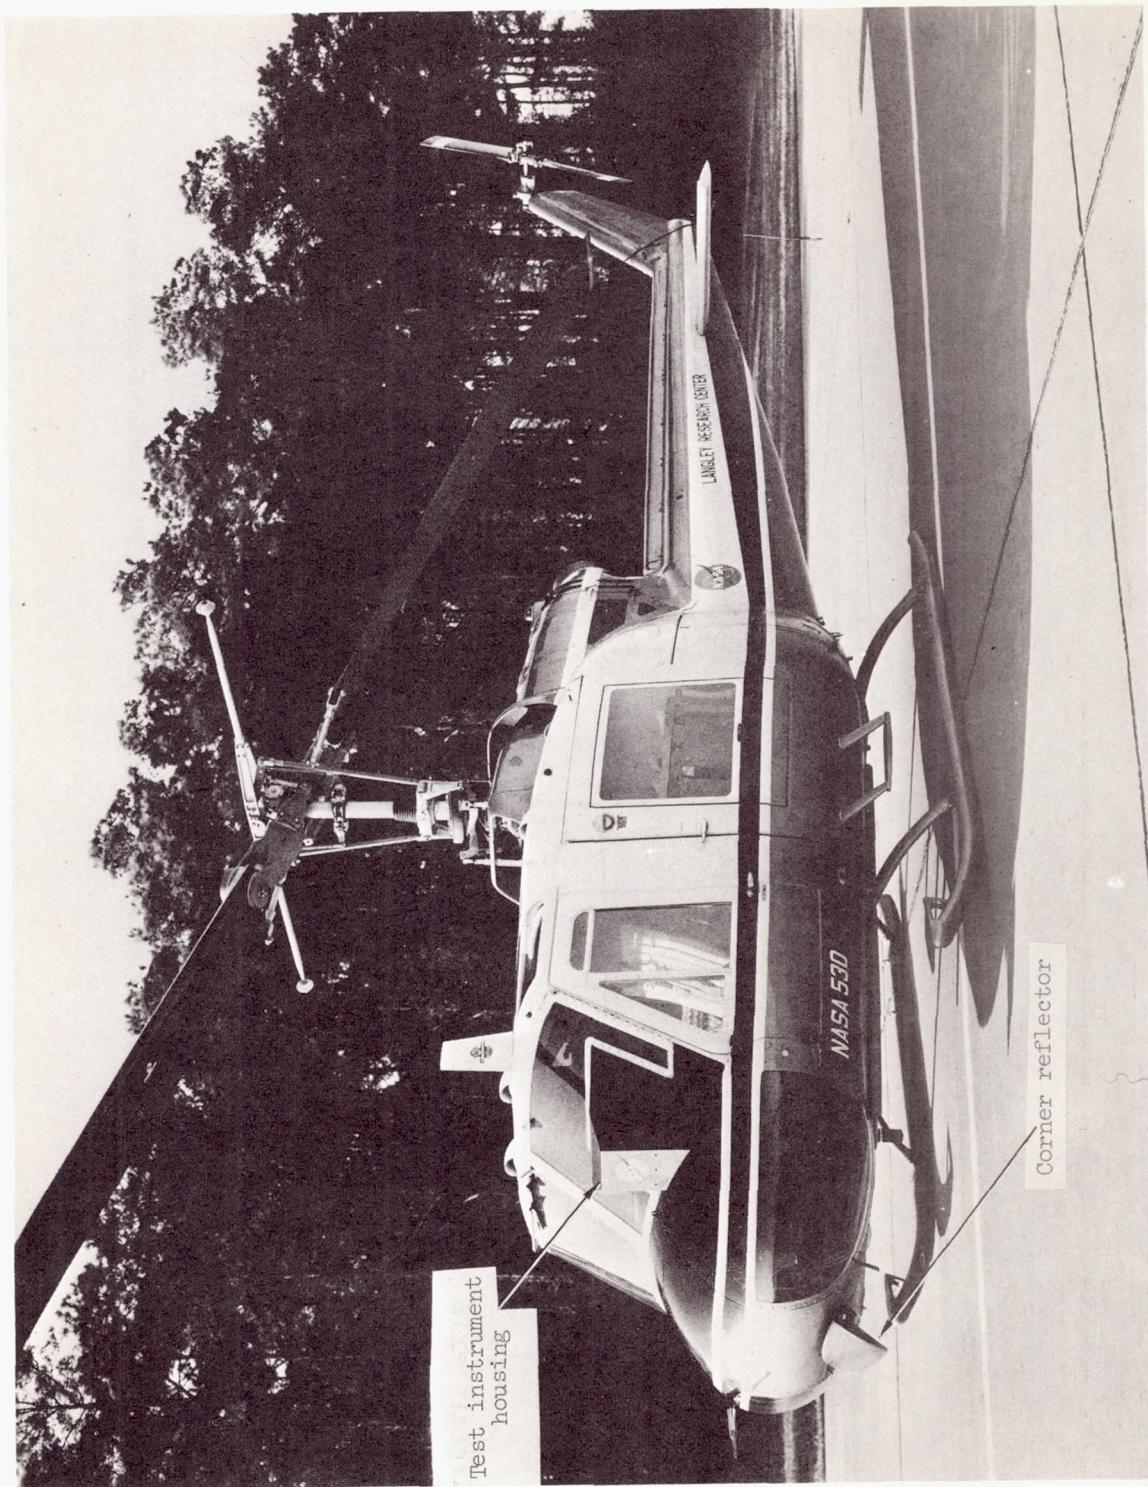
Figure 7.- Test helicopter.

The helicopter (fig. 7) used in the present tests was the same as that used for the tests reported in references 1, 2, and 3. This helicopter was not equipped with artificial stabilization. As shown in figure 7, a test instrument housing was installed through the left windshield and a radar-beam corner reflector was installed on the nose of the aircraft. The instrument display was located about 29 inches (73.7 cm) directly in front of the pilot's eyes.
